1441 Oak St. #4
Eugene, OR 97401

High-Rise Building In Eugene, OR 08/28/2014

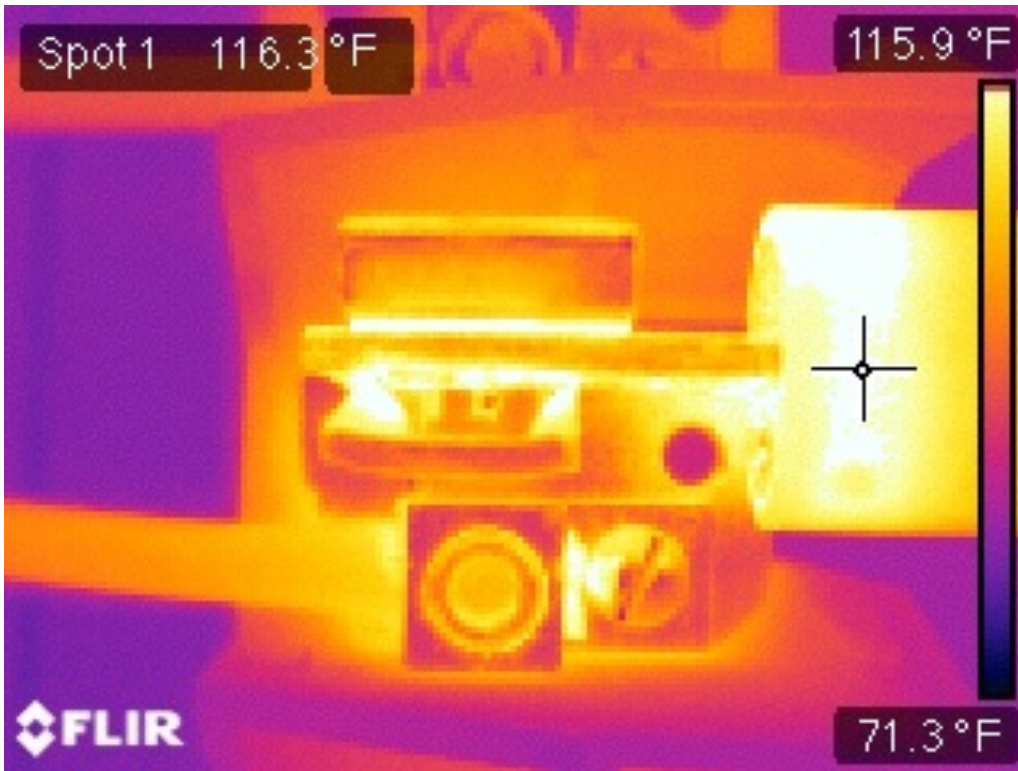
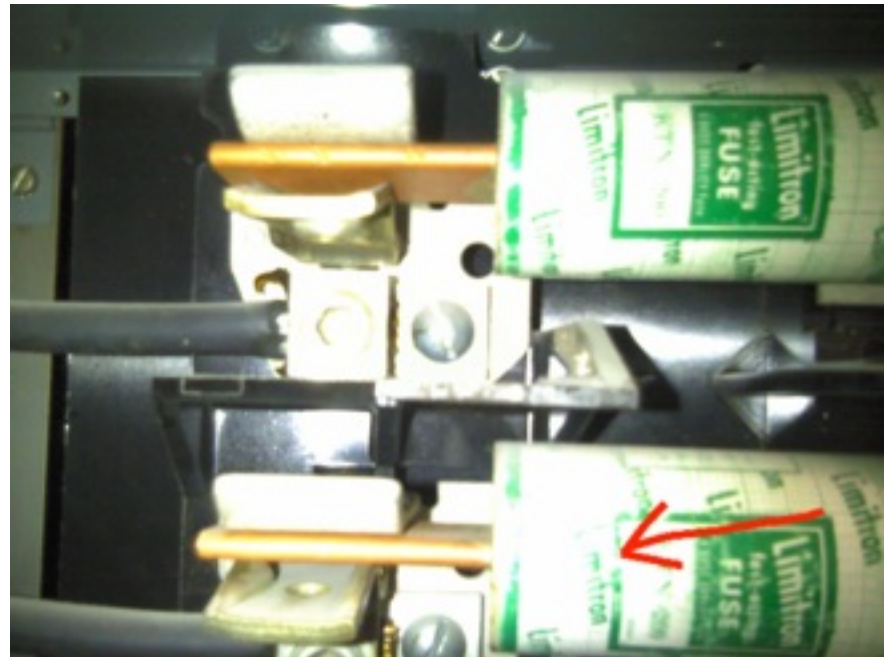
LOCATION: 10th Floor north electrical room.

EQUIPMENT: MCC 2 Fused disconnect.

NOTE: Disconnect fuse temps are elevated on the left side of the fuse. Amp meter readings were 32 Amps on the associated conductor and 11 Amps on the adjacent conductor.

MEASUREMENTS	
Spot 1	116.3
Spot 2	
Spot 3	
Spot 4

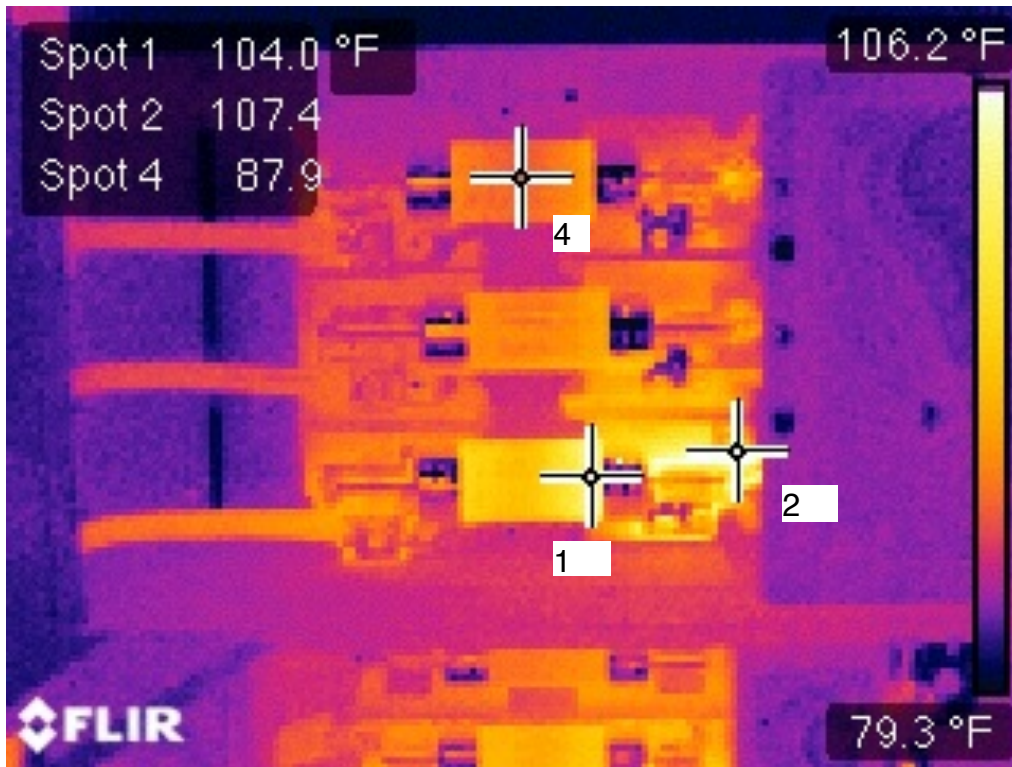
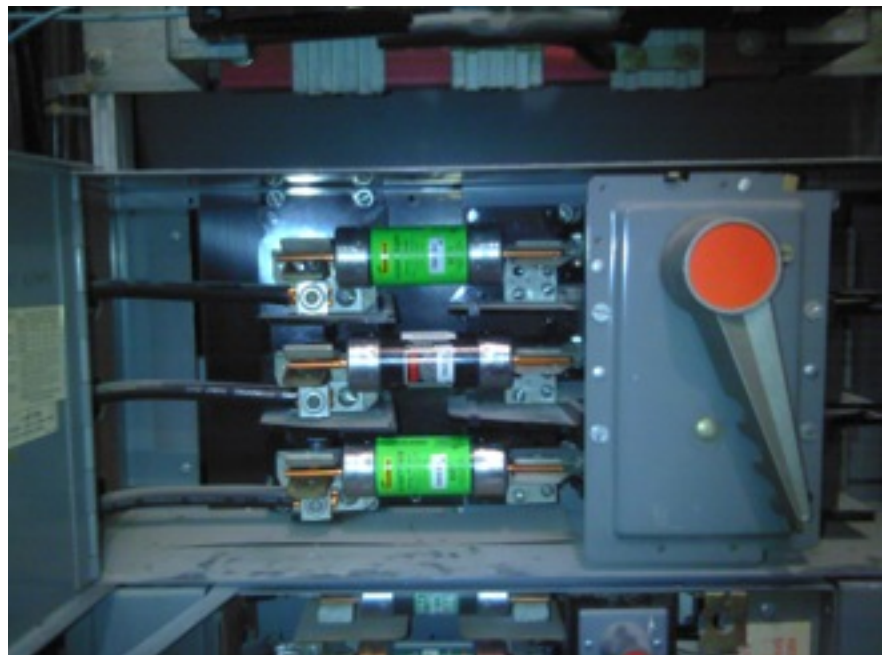
LOCATION: 9th Floor north electrical room

EQUIPMENT: 9L electrical panel.

NOTE: Elevated temp in neutral conductor. Scofield removed damaged section on conductor and re0installed conductor on neutral bus bar.

MEASUREMENTS	
Spot 1	104
Spot 2	107
Spot 3	
Spot 4	87

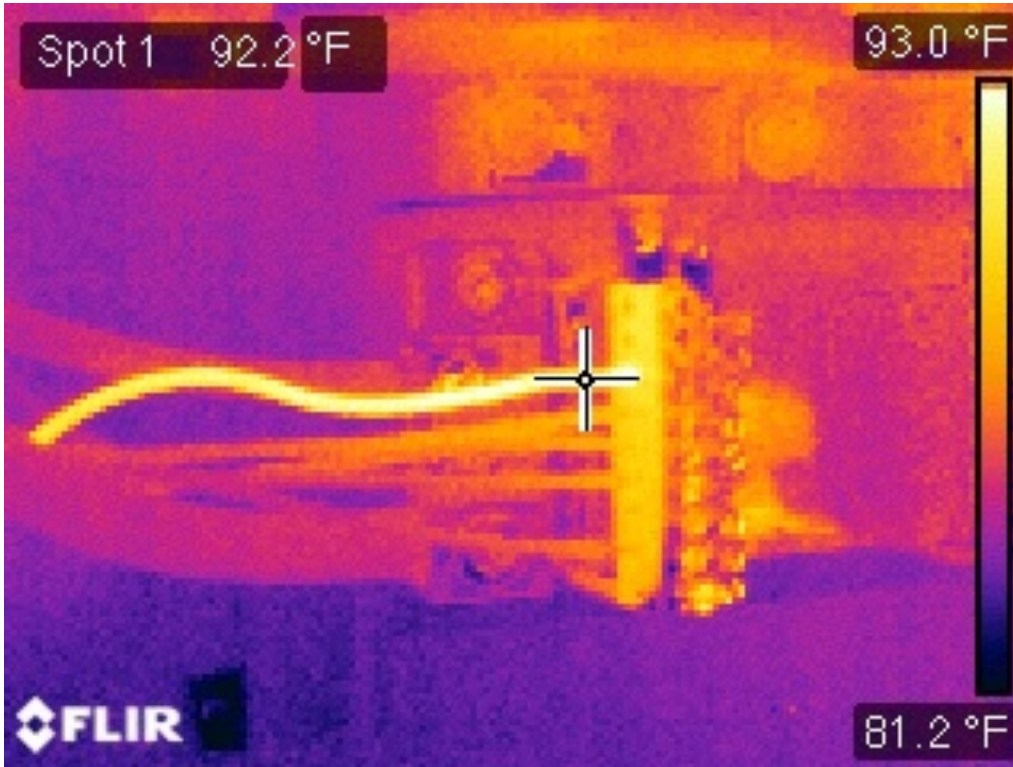
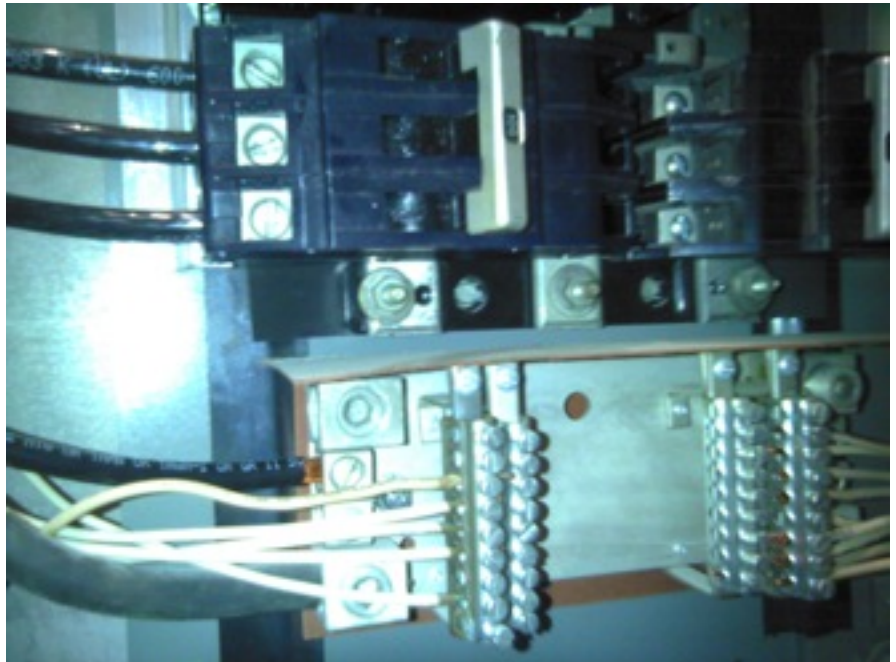
LOCATION: Mechanical room.

EQUIPMENT: MCC, condenser water pump #2

NOTE: Elevated temp on middle contact. Further evaluation recommended to determine source of heat.

MEASUREMENTS	
Spot 1	92
Spot 2	1
Spot 3	
Spot 4

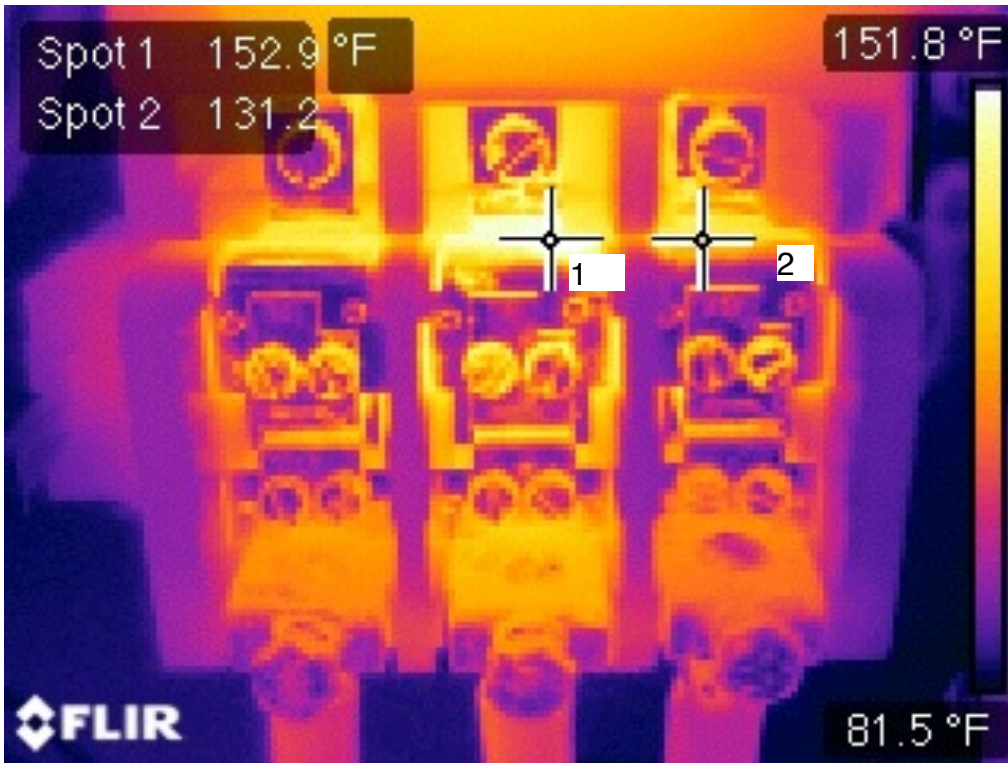
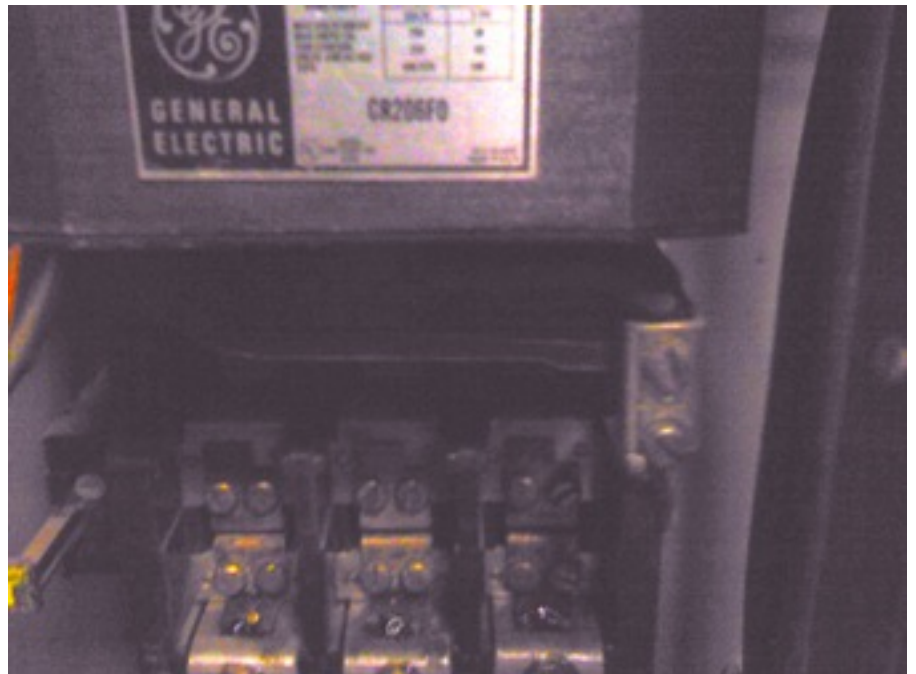
LOCATION: Mechanical room.

EQUIPMENT: MCC, chiller #2, compressor.

NOTE: Elevated temp in contactor lead fastener (bolt). Spot #1 on far left of image.

MEASUREMENTS	
Spot 1	152
Spot 2	131
Spot 3	106
Spot 4

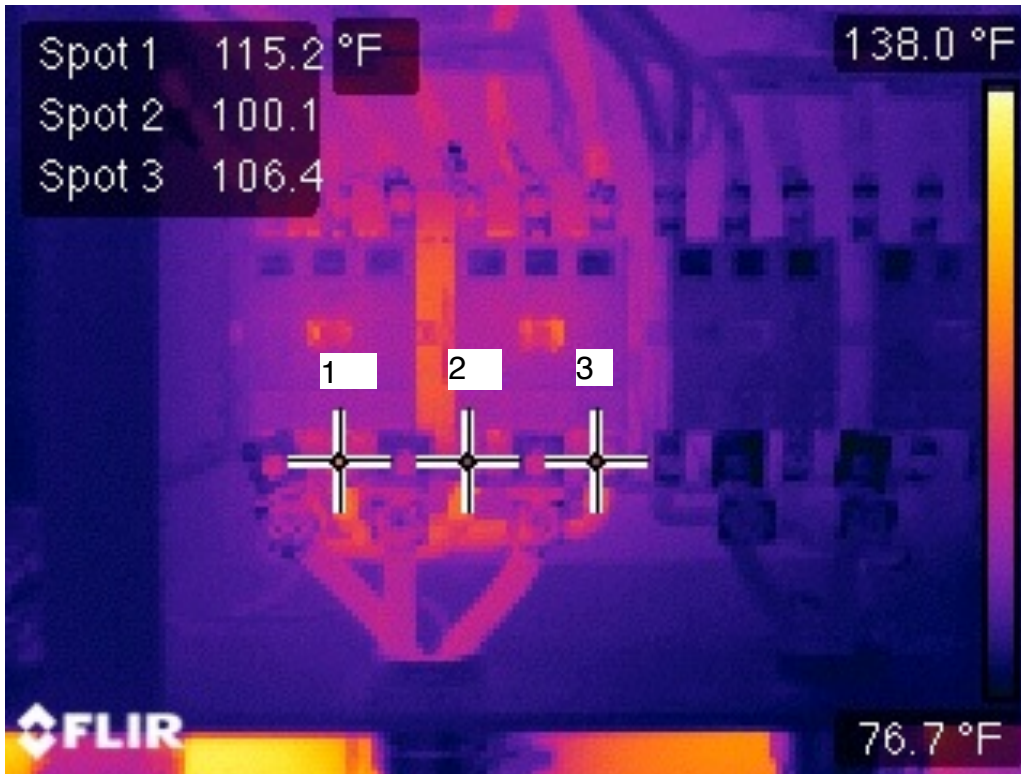
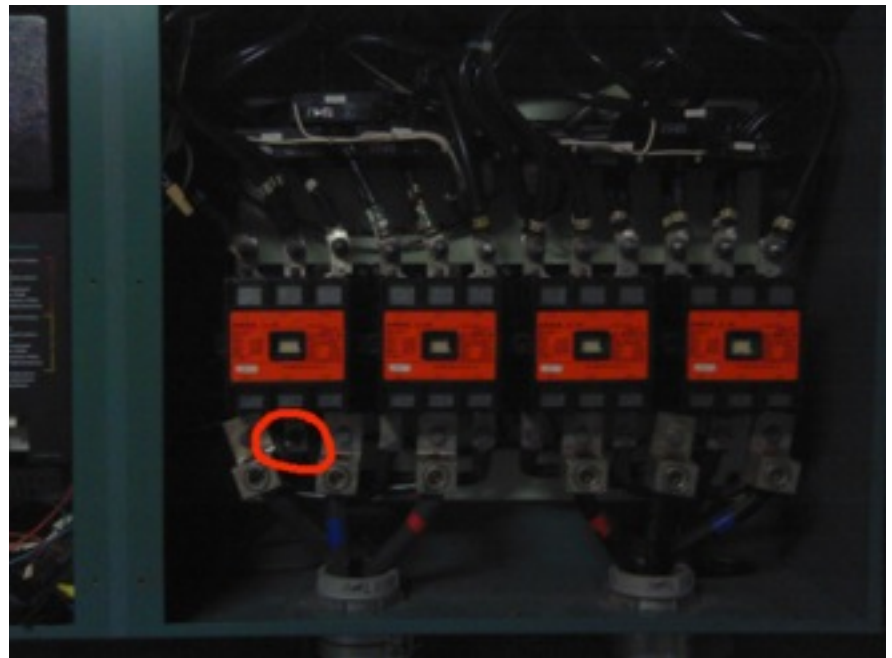
LOCATION: Basement mechanical room.
EQUIPMENT: Chiller #2, bottom block, fused disconnect
NOTE: Top two fuses are warmer than lower fuse. Note that the top two fuses are made by the same manufacture and the bottom is made by a different manufacture. Could just be difference in operating temps between the different manufactures.

MEASUREMENTS	
Spot 1	115
Spot 2	100
Spot 3	106
Spot 4

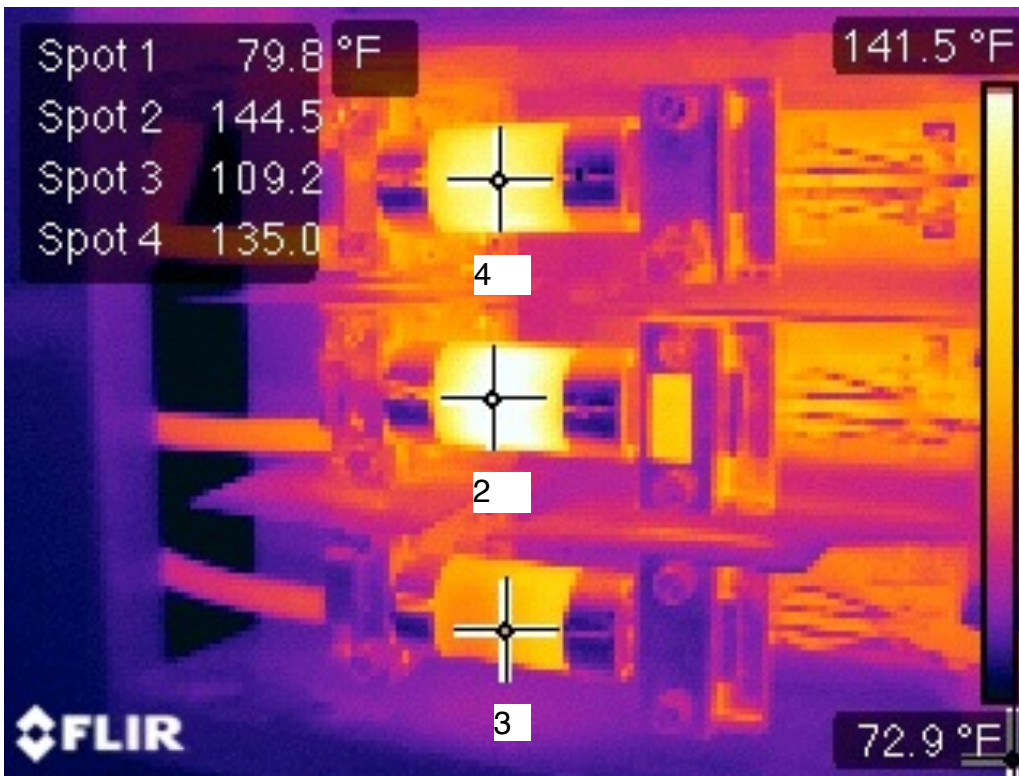
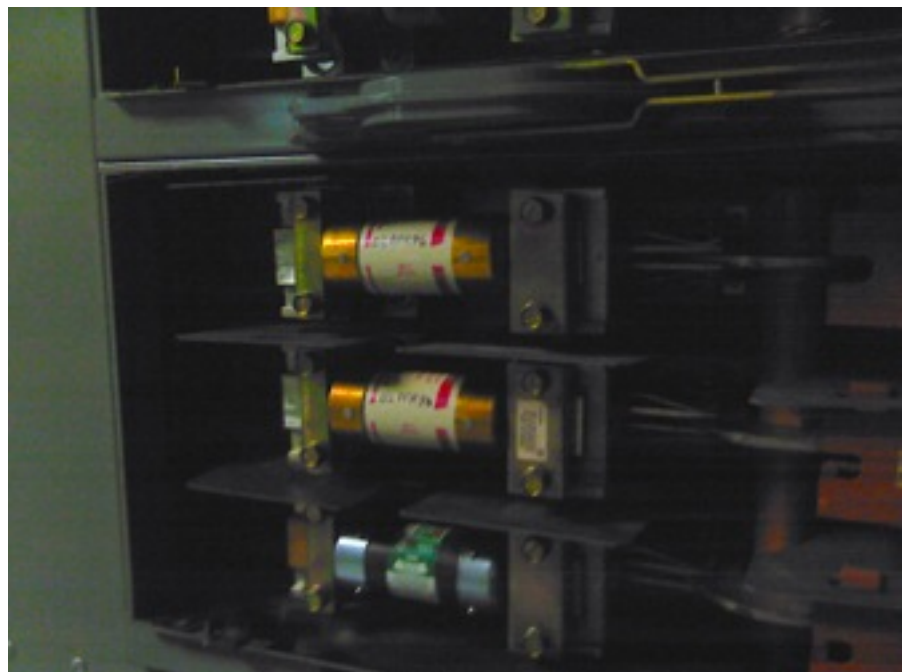
LOCATION: Basement, main electrical room.

EQUIPMENT: South chiller disconnect.

NOTE: Middle contacts (Spot #1) are showing elevated temps.

MEASUREMENTS	
Spot 1	79
Spot 2	144
Spot 3	109
Spot 4	NA

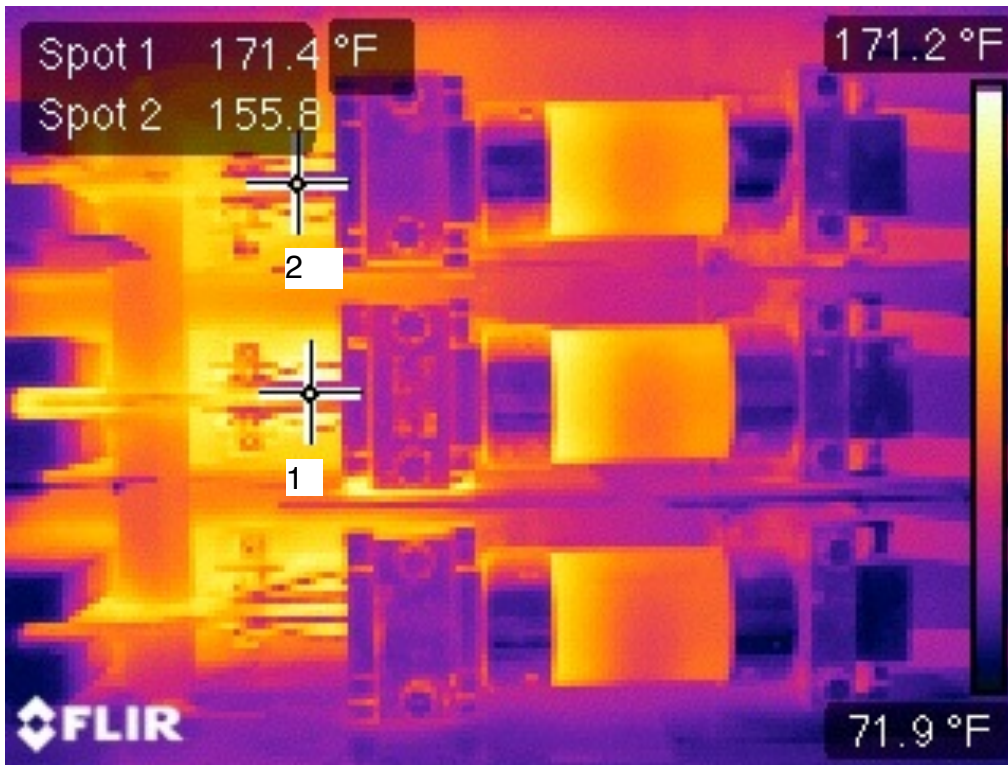
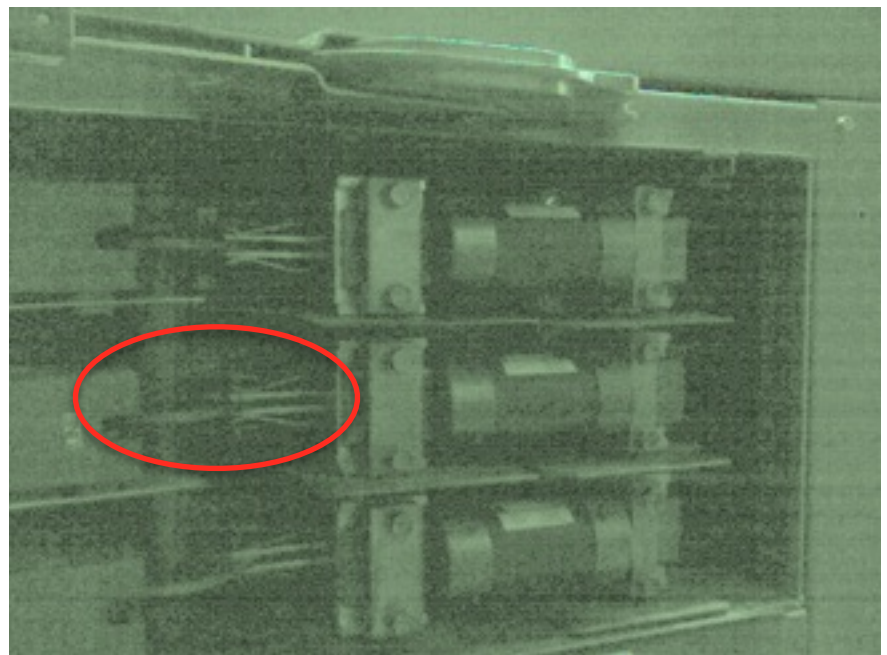
LOCATION: Basement, main electrical room.

EQUIPMENT: Main service disconnect for building.

NOTE: No issues noted.

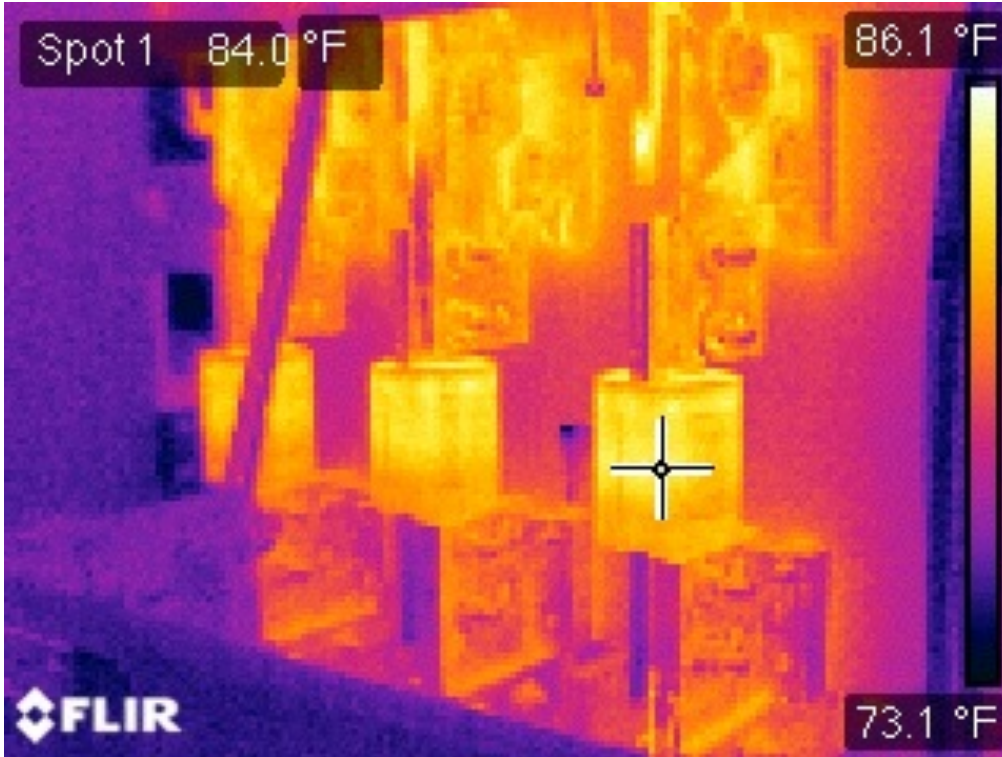
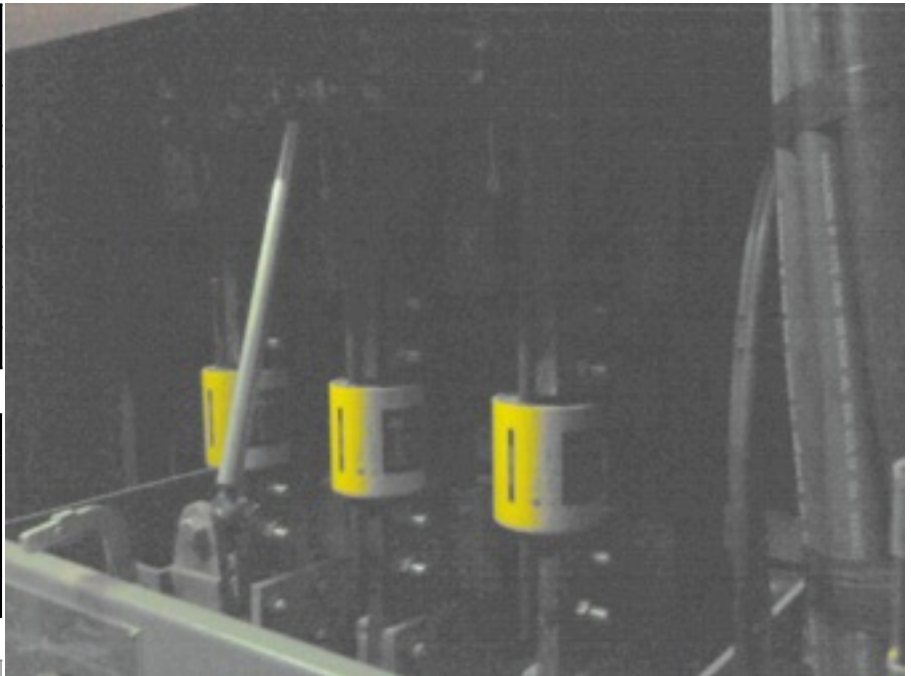
LOCATION: Basement, main electrical room.

EQUIPMENT: Mechanical room disconnect.

NOTE: No issues noted.

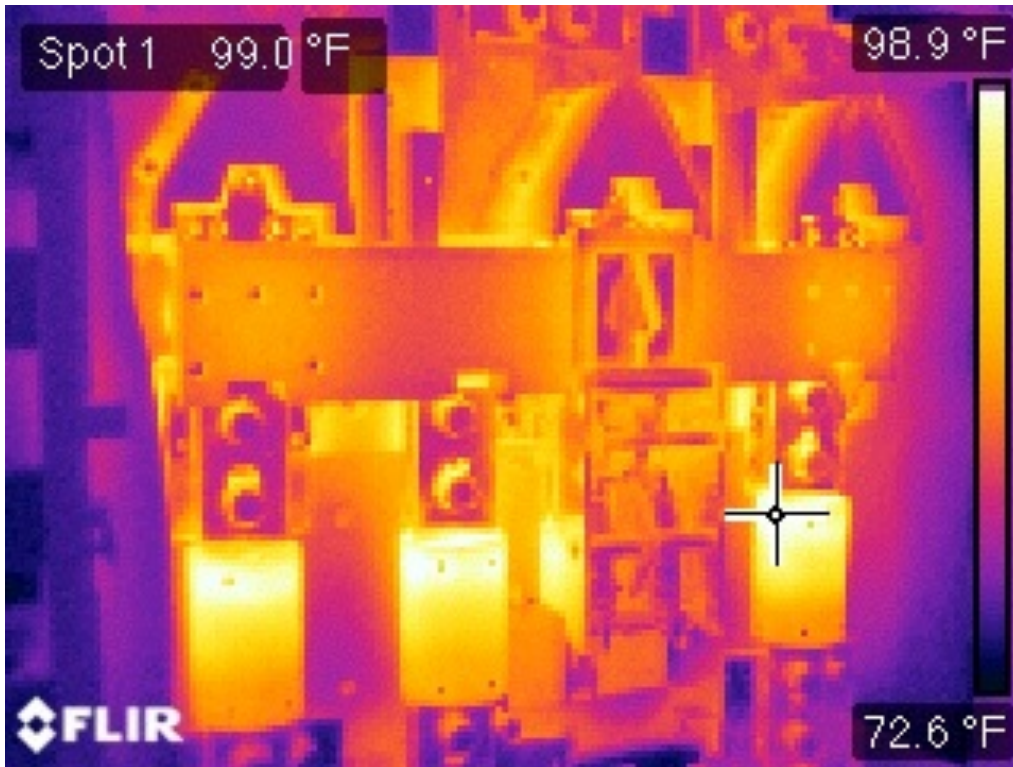
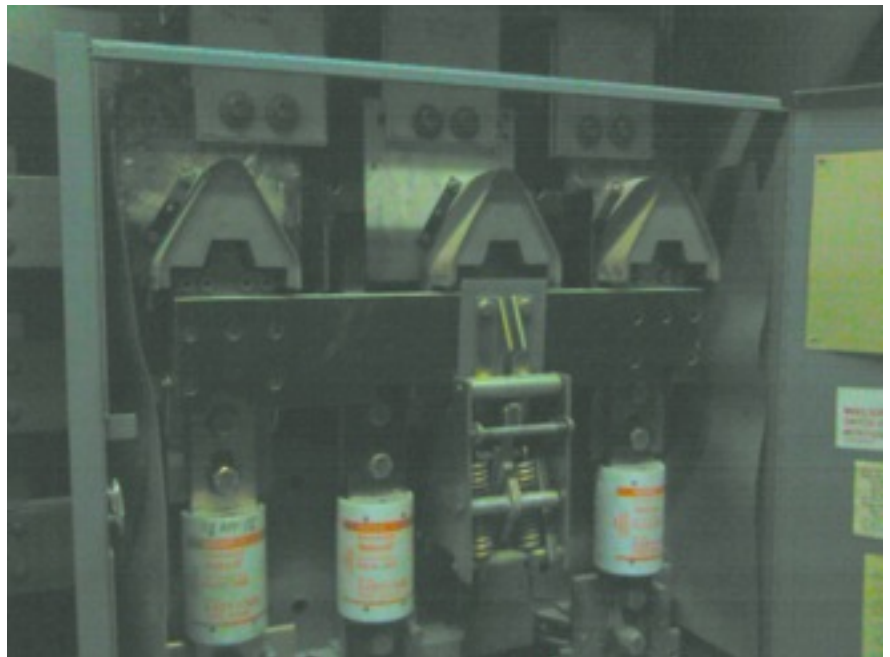
LOCATION: Basement, main electrical room.

EQUIPMENT: Main Electrical disconnect for the building.

NOTE: No issues noted.
