# THE INSPECTION REPORT

## 3339 Bentley Avenue

Date of Inspection: 2/3/2021 Time: 9:00

Inspector: S. Luke Rabun

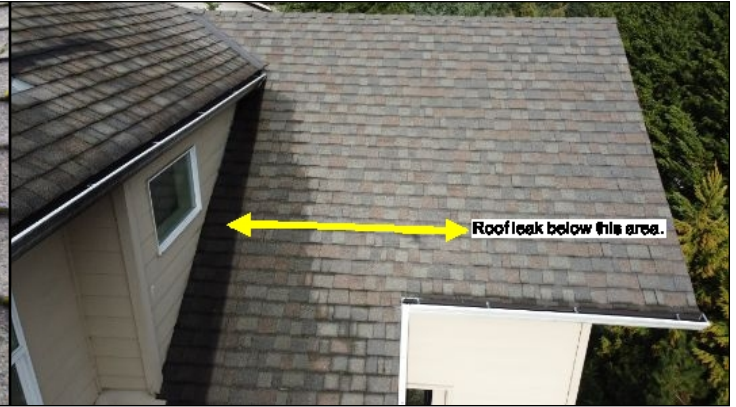
Roof leak below this area.

- Roof leak.
- @ Over the backdoor on the main level. Water was observed dripping out from above the soffit vents.
- Fastener are not sealed.
- @ An under driven nail has backed out of the shingles and sticking out of the shingles. The lower roof above the garage.
- No under layment/felt paper under the roof shingles.

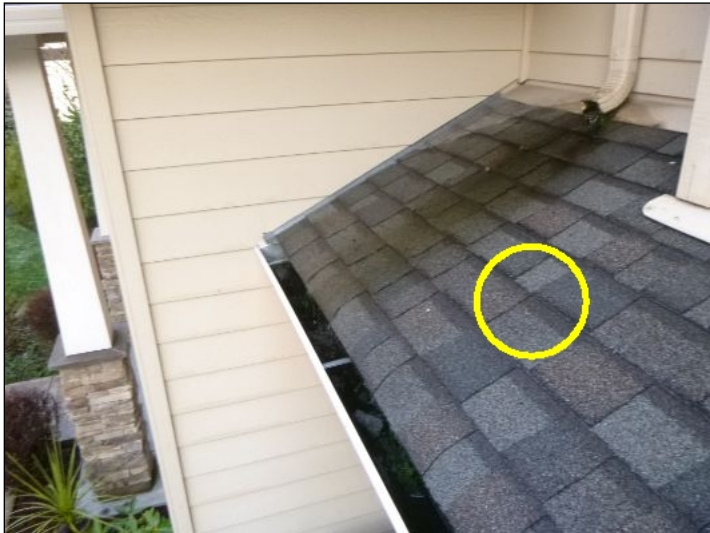
Nail sticking out of the shingles.

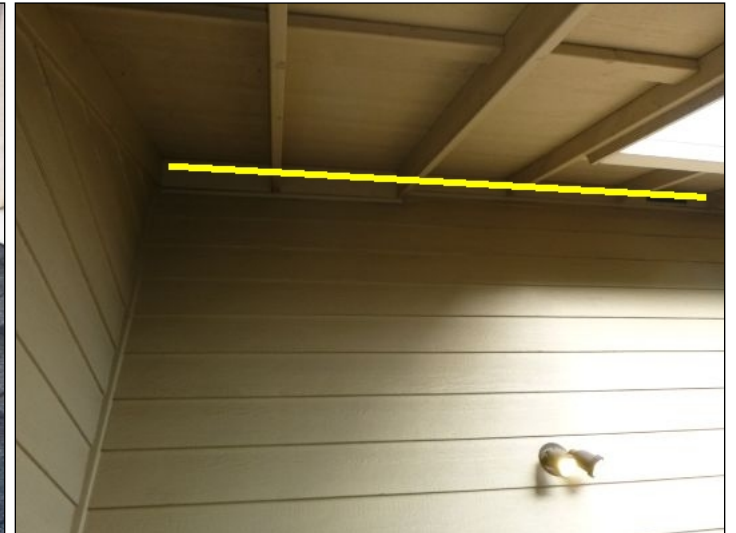
Roof Leak.

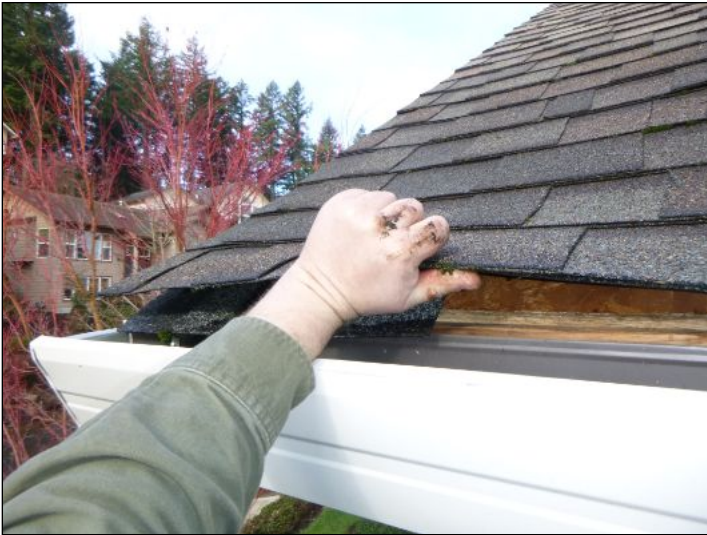
No underlayment

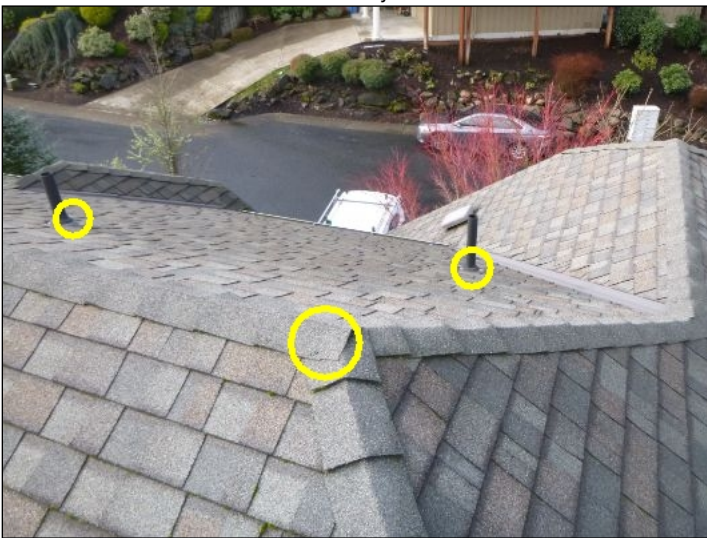
Fasteners are not sealed.

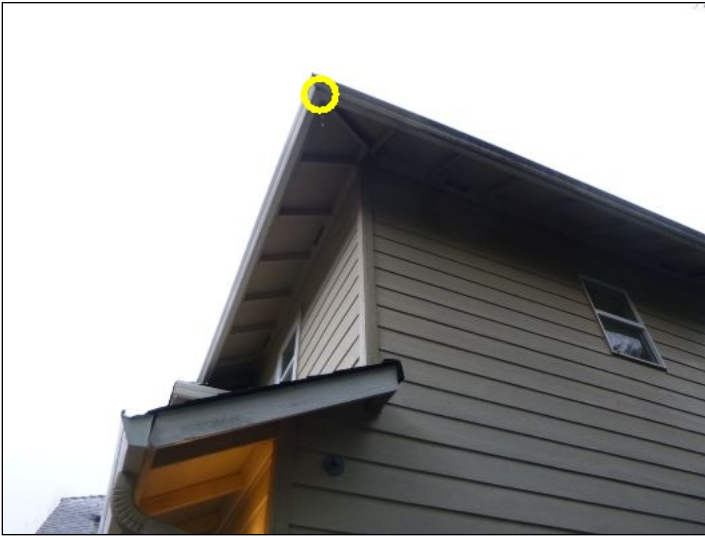
Leak in gutters.

- Downspouts needs to be reconnected to the underground drain line.  
@ Front left side of the house.
- Leak in the gutters appears to from missing sealant at the seams in the gutters such as the corners and end cap locations.  
@ Upper gutter on the front right corner of the house.

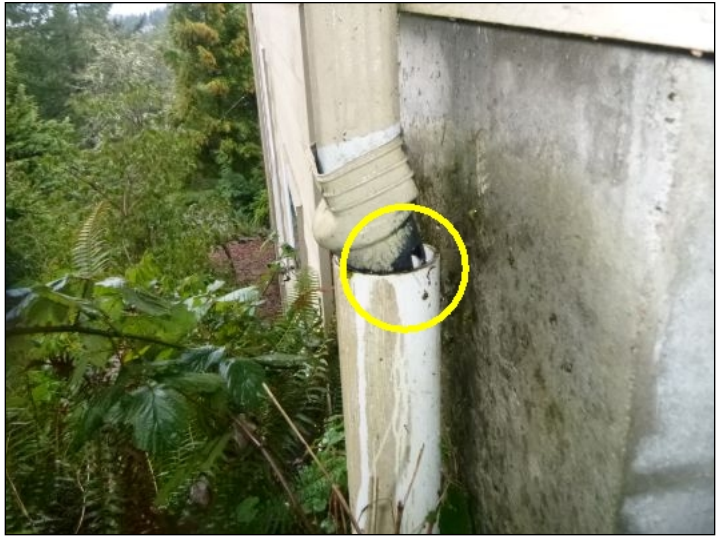
Reconnect downspouts at underground drainage system.

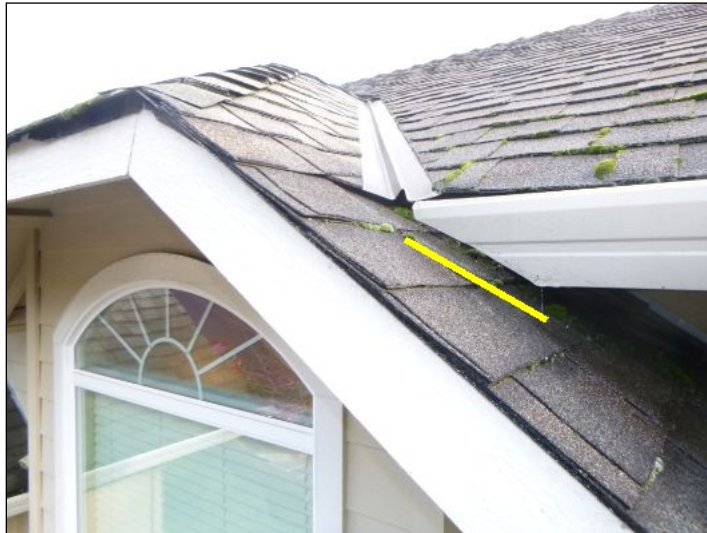
Gutter drains directly onto the shingles.

- Gutter drains directly onto the shingles instead of through a downspout. Typically where an upper roof drains onto a lower roof. This condition is prone to debris and water build up against the shingles.

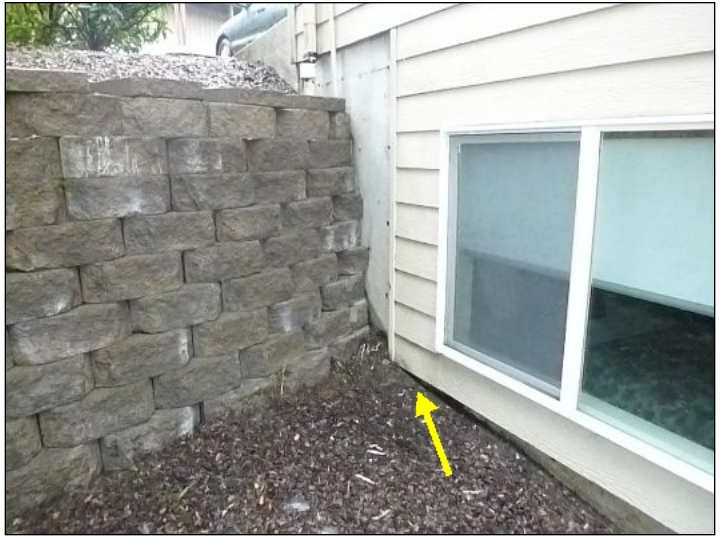
Clearance between the ground and the siding is inadequate.

- Clearance between the bottom of the siding and the ground was inadequate.  
@ On both sides of the house.
-

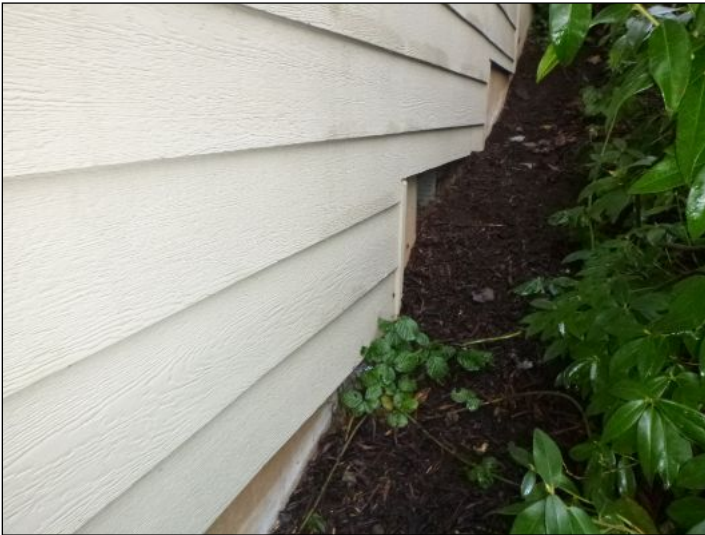
Clearance between the ground and the siding is inadequate.

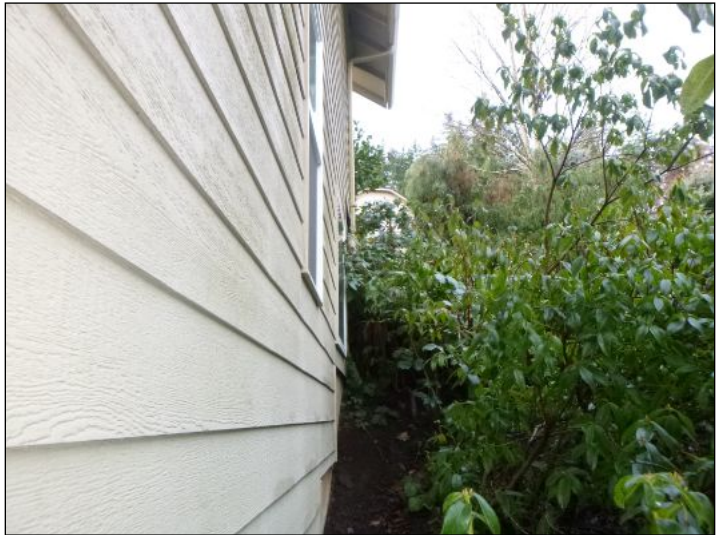
Vegetation with 12"

- Significant cracks in walkways or driveways: \_\_\_\_\_ NO
- Significant vegetation within 12" of the siding: \_\_\_\_\_ YES (Improvement Recommended)
- Uneven walkways that pose a significant trip hazard: \_\_\_\_\_ NO

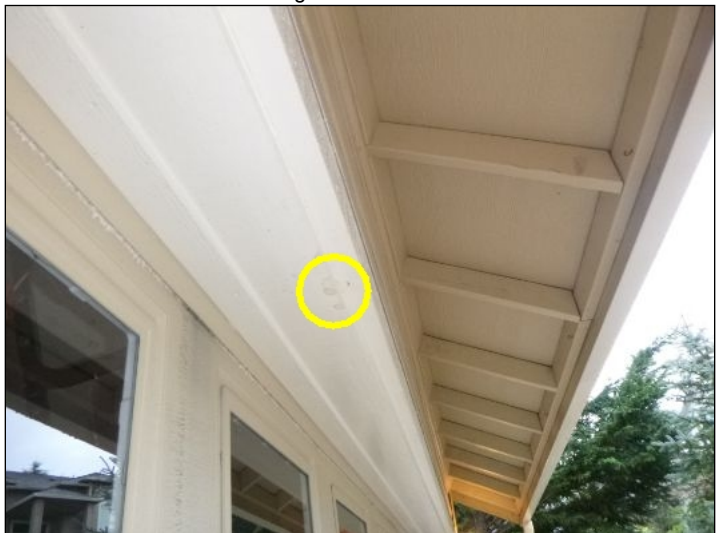
Water stains.

- Water stains or signs of moisture. No elevated moisture levels detected at this time of the inspection. I did not see any obvious defects that would lead to water intrusion however if you'd like a second opinion consider consulting a roofing or siding contractor.  
@ Above the garage door.

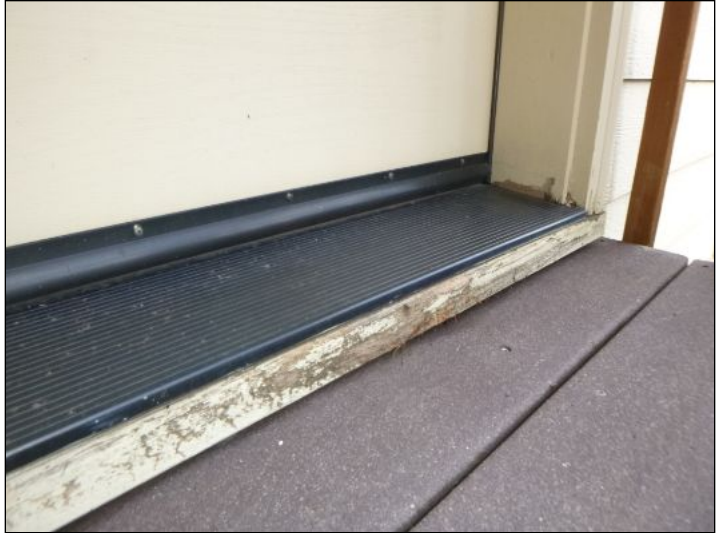
Damaged paint

- Window screens are missing.
  - Sealant needs improvement. The home had sealant installed over, around, or between areas such as the doors, windows, trim boards, butt joints (that were not flashed), nails heads, penetrations in siding (pipes, wiring, etc.), or around chimneys and trim to prevent moisture intrusion into the building cavities.
  - Paint was damaged, peeling, or chipped.  
@ In a few areas of the trim and fascia boards.
-

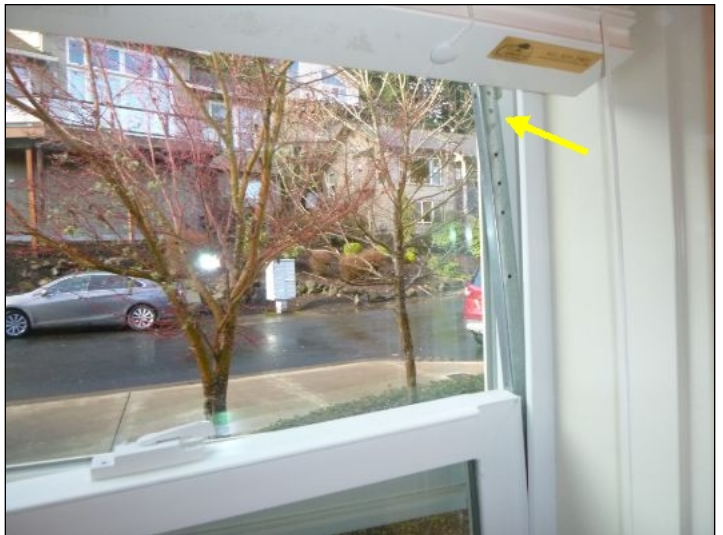
Sash balance(s) was damaged.

- Sash balance was damaged. This is the mechanism that hold the window up when it's opened.  
@ The upstairs hallway bathroom.
  - Door damage.  
@ The door hinge is loose in the downstairs bedroom on the left making the bind on the door jam when closing.
-

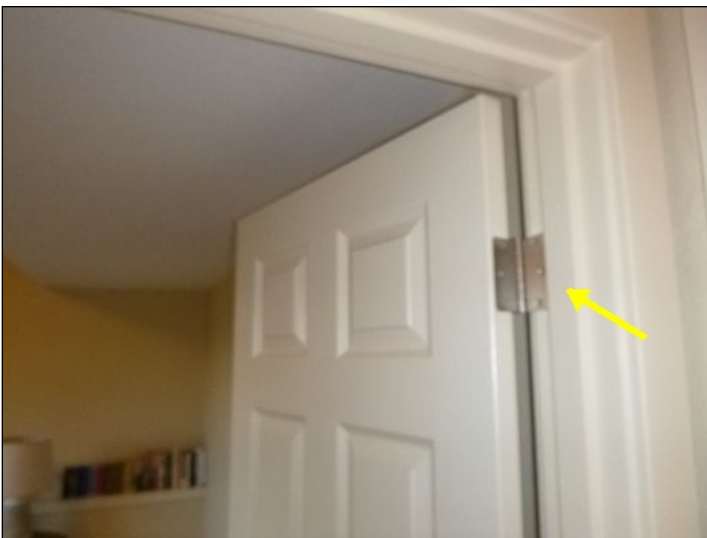
Loose door hinge

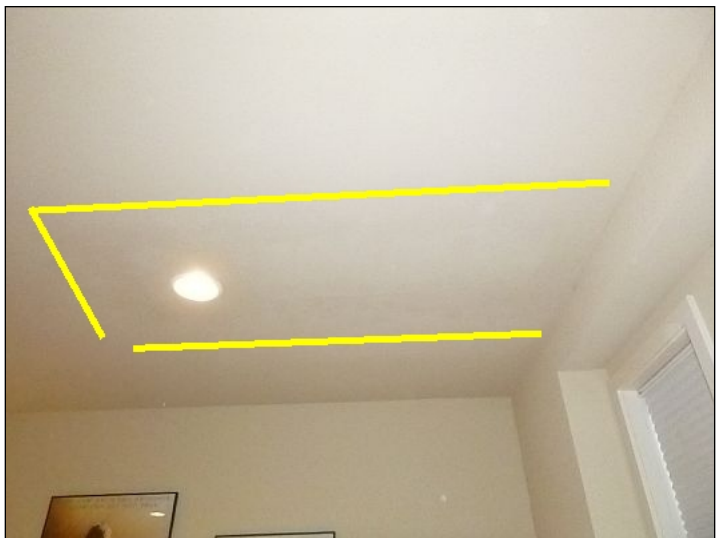
Old drywall repair. What happened?

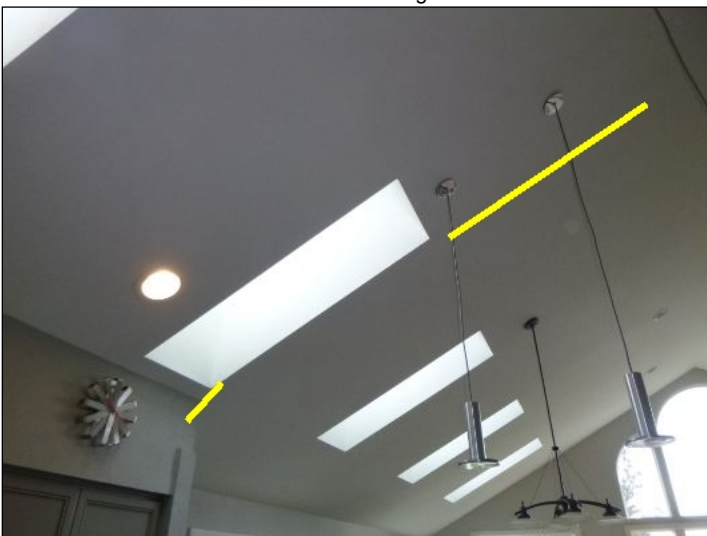
Cracks in ceiling.

- Cracks from expansion & contraction. Cracks in the drywall in walls in the home appeared to be the result of expansion and contraction of building materials or settling. Some cracking is not unusual in a home of this age. In the opinion of the inspector these cracks do not appear to be a structural safety concern at this time and are only cosmetic. If you would like a second opinion, I would recommend consulting a structural engineer.  
@ In the ceiling over the kitchen area.

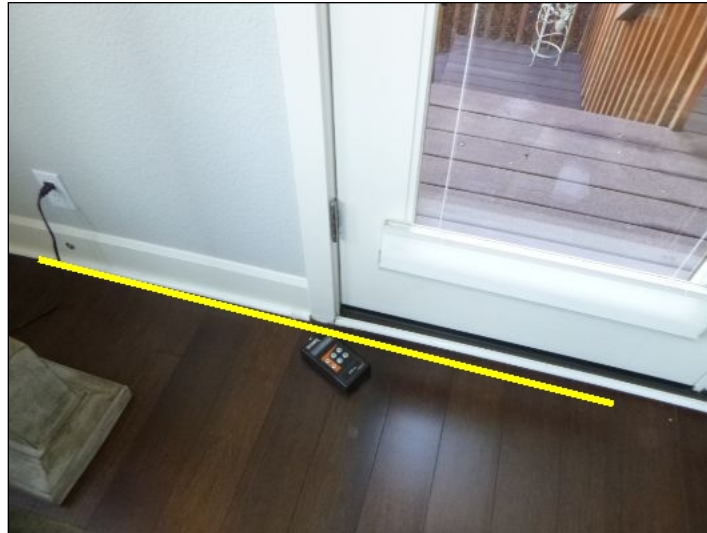
Moisture levels in the floor are elevated.

- Moisture levels are elevated.  
@ At the base of the backdoor on the main level. On the left side of the Moisture in the floor and minor water damage to the base trim.
  - The wine fridge doesn't work or I don't know how to turn in on.
-

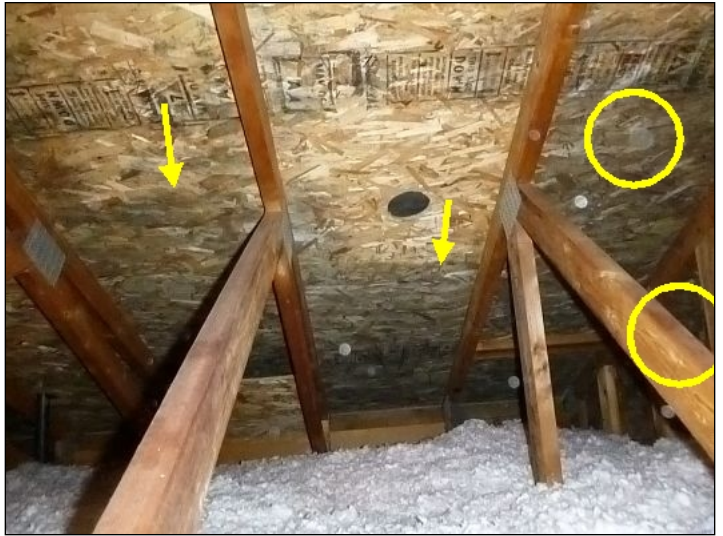
Roof sheathing is stained.

- *Water stains or signs of moisture on the roof framing or roof sheathing. NO elevated moisture levels. If you would like a second opinion consult a roofing contractor.*
- *@ Over the master bedroom and bathroom. This condition is likely a result of one or more of the conditions noted in the Roof section of this report.*

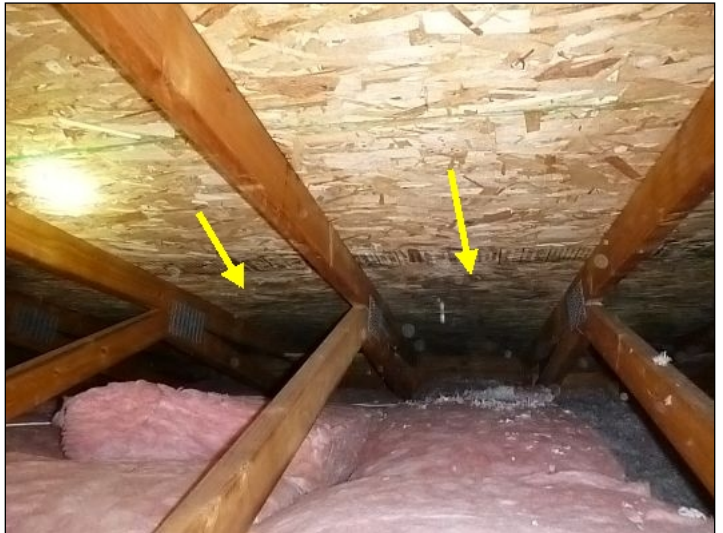
Roof sheathing is stained.

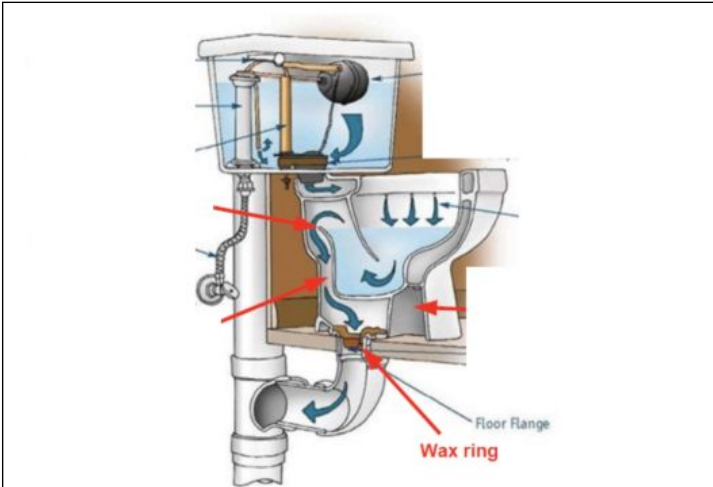
Moisture levels in sub flooring is elevated. This is often due a damaged wax ring.

PLUMBING		
Page 29 Item: 3	Interior	<p><b>CORRECTION AND FURTHER EVALUATION. Descriptions &amp; approximate locations include but are not limited to:</b></p> <ul style="list-style-type: none"> <li>- Elevated moisture levels at the base of the toilet. This typically indicates that the seal between the floor and toilet has gone bad. @ The downstairs bathroom.</li> </ul>
SMOKE & CARBON MONOXIDE ALARMS

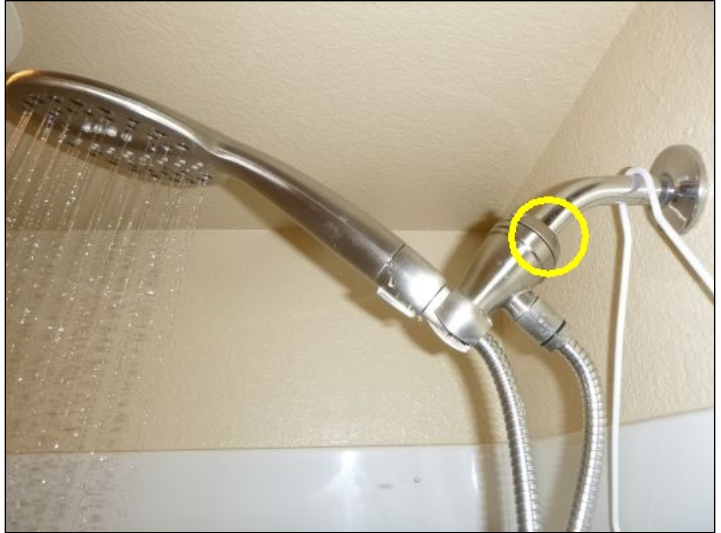
Water leak.

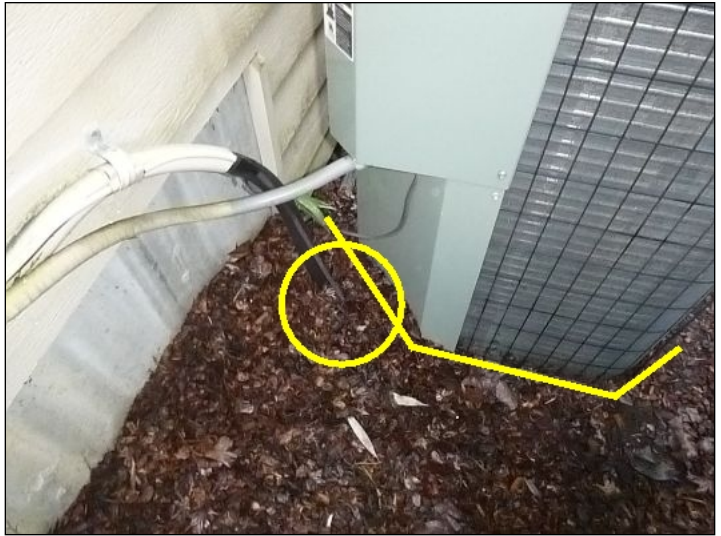
Remove bark around heat pump

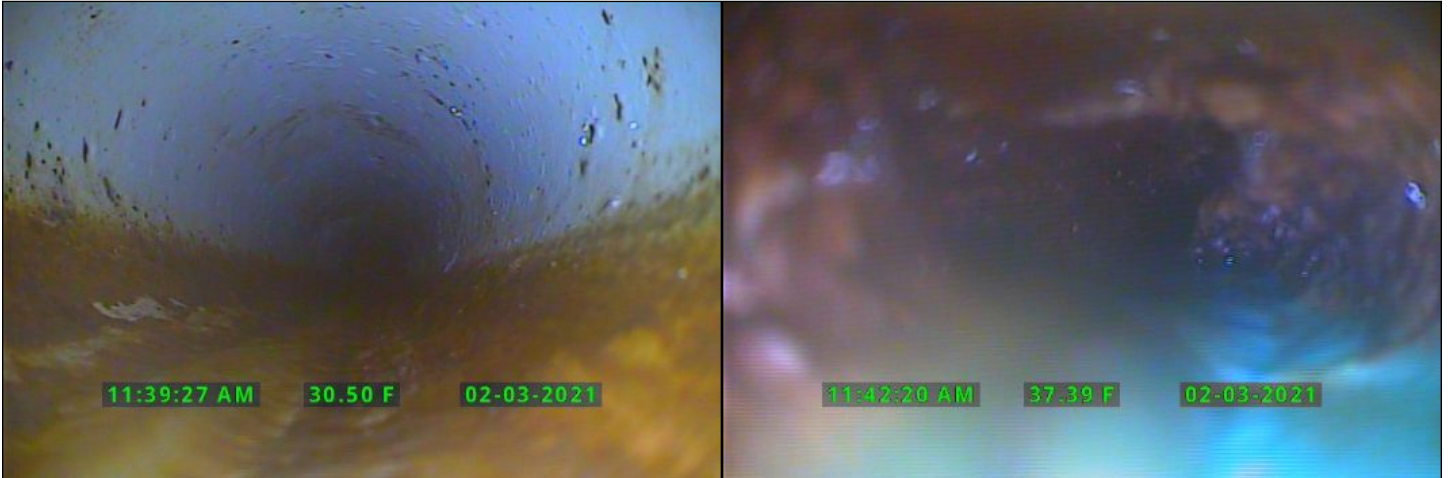
Plastic Pipe

Root intrusion in pipe.

Page 32 Item: 3	Findings	<i>CORRECTION AND FURTHER EVALUATION. Descriptions &amp; approximate locations include but are not limited to:</i>  <i>- Expired smoke alarm. Smoke alarm units expire after 10 years. The units themselves, not just the battery.</i> <i>@ In all locations.</i>
<b>SEWER CAMERA INSPECTION</b>		
Page 35 Item: 4	Findings	<i>CORRECTION AND FURTHER EVALUATION. Descriptions &amp; approximate locations include but are not limited to:</i>  <i>- Root intrusion and significant blockage. I'd recommend cleaning and another inspection of the pipe to determine the cause of the root intrusion.</i>

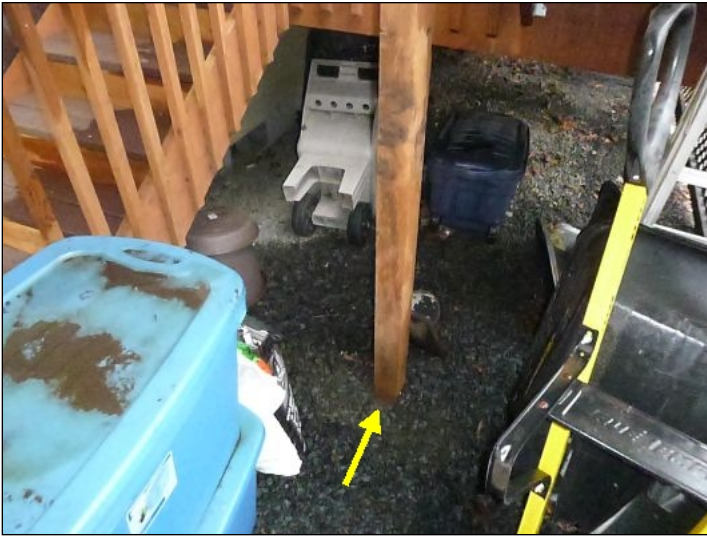
Wood to earth contact

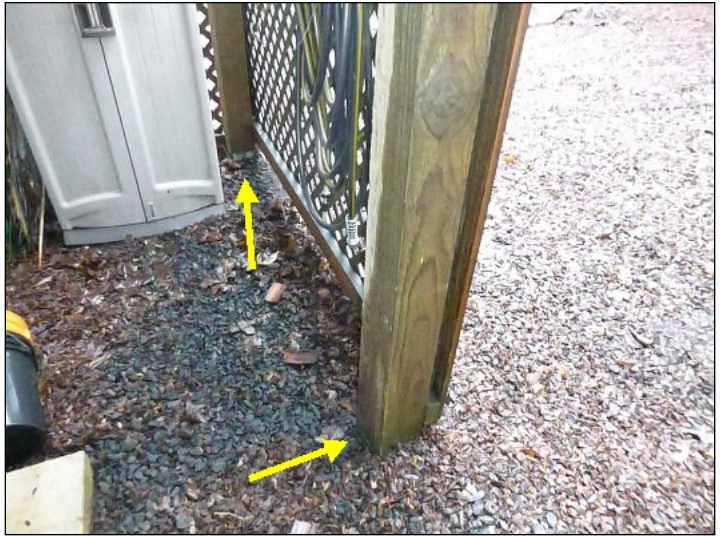
Wood to earth contact
